Dream Home Inspections LLC

*** Residential Inspection Report ***

117B North Ocean Blvd.
Surfside Beach, SC

Date Of Inspection: July 1, 2013

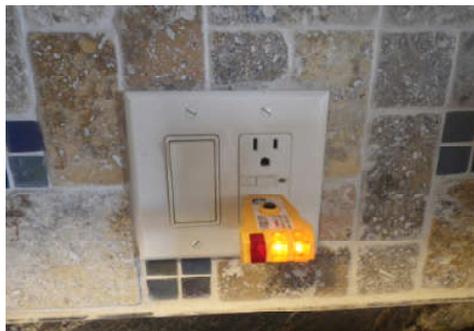
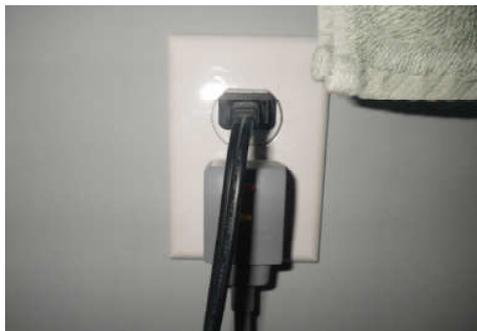
Observation: The GFCI outlet located in kitchen above counter top to the right of range did not trip when it was tested. This outlet needs to be replaced immediately. The outlet in the upstairs master bedroom bath needs to be replaced with a GFCI outlet.

- The GFCI outlet located in kitchen above counter top to the right of range did not trip when it was tested. This outlet needs to be replace immediately. The outlet in the upstairs master bedroom bath needs to be replaced with a GFCI outlet.

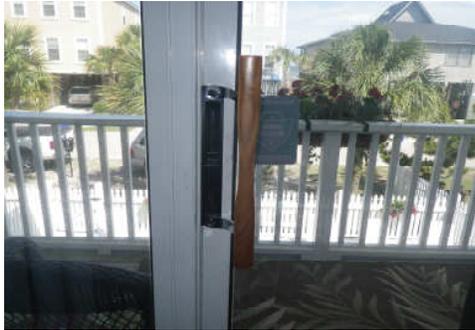
Further Comments: The sliding glass door on the 1st and 2nd floors had an inoperable latch. Recommend repair.

- The sliding glass door on the 1st and 2nd floors had an inoperable latch. Recommend repair.

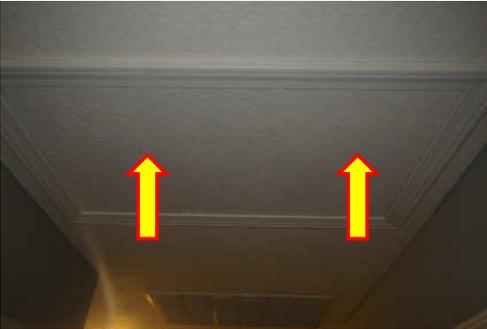
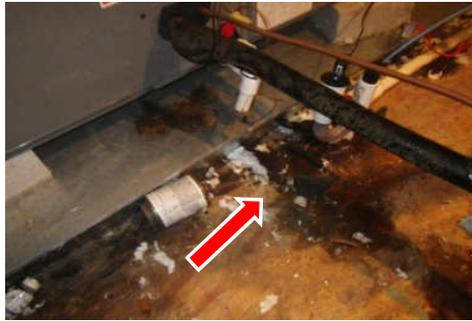
Further Comments: The attic HVAC unit drain line trap is plugged allowing water to overflow onto the plywood structure supporting the unit. Moisture will cause the growth of mold. Recommend having the trap cleaned.

- The attic HVAC unit drain line trap is plugged allowing water to overflow onto the plywood structure supporting the unit. Moisture will cause the growth of mold. Recommend having the trap cleaned.

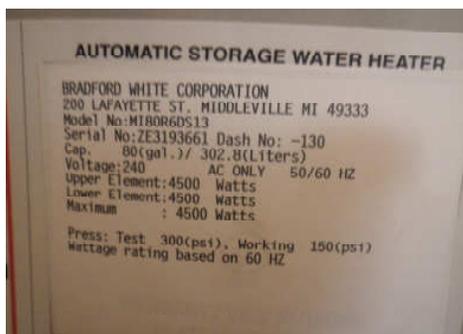
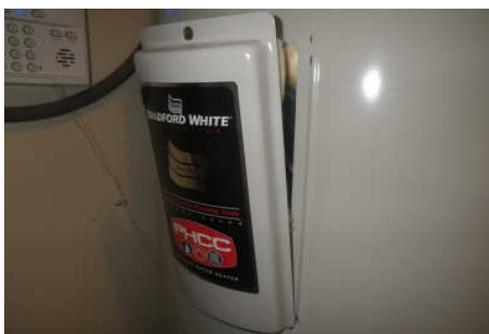
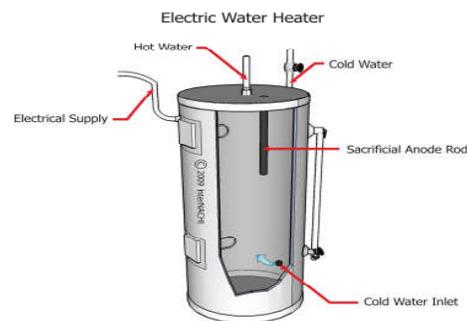
cover plate on hot water heater is missing screw for cover. Recommend replacing screw so not to allow accidental electrocution.

- cover plate on hot water heater is missing screw for cover. Recommend replacing screw so not to allow accidental electrocution.

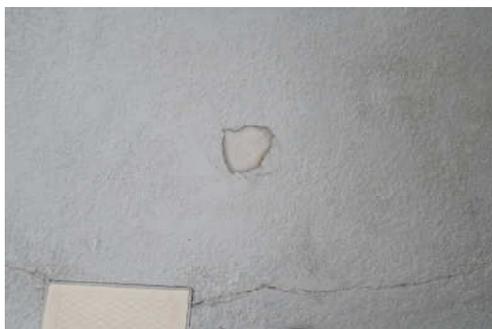
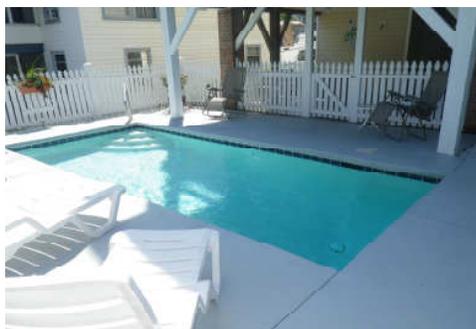
Further Comments: Loose material
