Dream Home Inspections LLC

*** Residential Inspection Report ***

117B North Ocean Blvd.
Surfside Beach, SC

Date Of Inspection: July 1, 2013

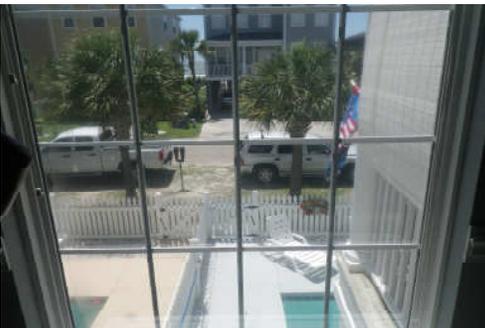
Further Comments: The sliding glass door on the 1st and 2nd floors had an inoperable latch. Recommend repair.

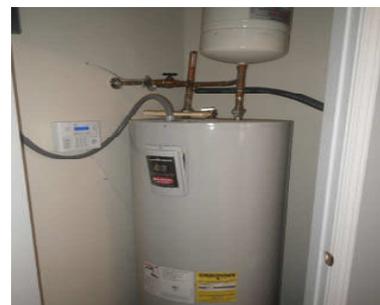
cover plate on hot water heater is missing screw for cover. Recommend replacing screw so not to allow accidental electrocution.
